Case Study

Seismic Sustainability Assessment of Lavasan City

RUNNING TITLE: Seismic Sustainability Assessment

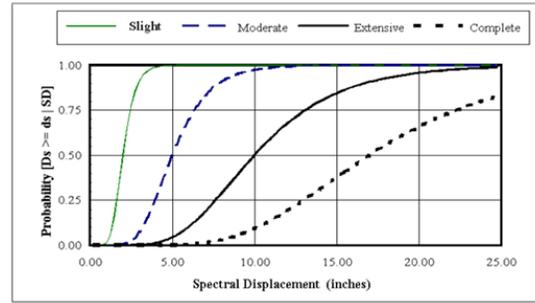
Fig 2: Fragility Curves for Slight, Moderate, Extensive and Complete Damage (IBC, 2006)

Building damage functions are in the form of semi logarithmic fragility curves which relate the probability of reaching or exceeding a building damage state for a given PESH (Potential earth science hazards) demand parameter (e.g., displacement response spectrum). Figure 2 provides an example of fragility curve for four damage states used in this methodology.

Each fragility curve is defined by a mean value of the PESH demand parameter (i.e., either spectral displacement, PGD, spectral acceleration, PGA) corresponding to the damage state threshold and its variability. For example, the spectral displacement, S_d , which defines the threshold of a particular damage state (ds) is assumed to be defined as follow (HAZUS, 2003):

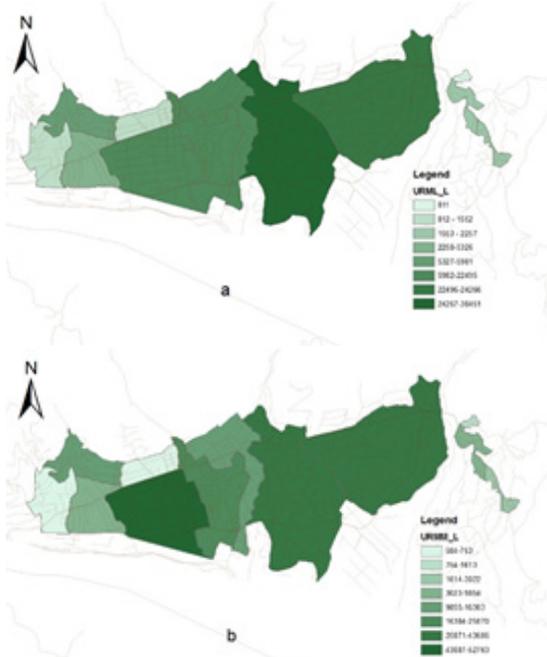
Fig 3: Area of masonry buildings with extensive damage in different areas of Lavasan city(m2), a: 1 story, b: more than 1 story

In every seismic risk assessment, majority of casualties belong to Masonry buildings. Regarding the history, the city of Lavasan has lots of these structures. Although, all masonry buildings in the city are supposed to be rehabilitated or substituted with RC and steel structures, in the current situation we need to know which of regions are in the top priority. The old area of Lavasan city, including areas 6, 9, 10, 11 and 12, shows the highest ratio of damages. In contrast, areas 1, 2, 3, 4, 7 and 8 have a lower damage ratio due to newer structures according to the standards. Areas 6 and 9 have a high damage ratio due to the large number of settlements. Soil type is also one of the influential factors in the amount of damage, which in terms of this effect in the design of structures can reduce the damage.

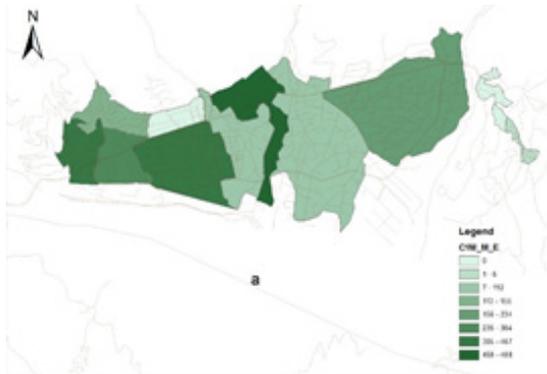
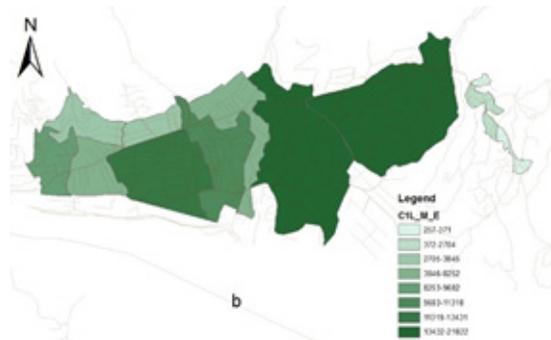
Fig 4: Area of Concrete Moment Frame buildings with extensive damage in different areas of Lavasan city(m2), a: 4 to 8 story, b: 1 to 3 story

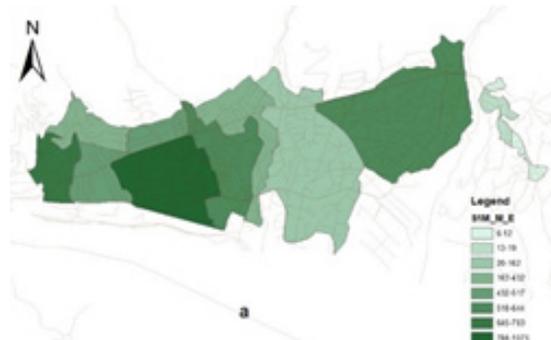
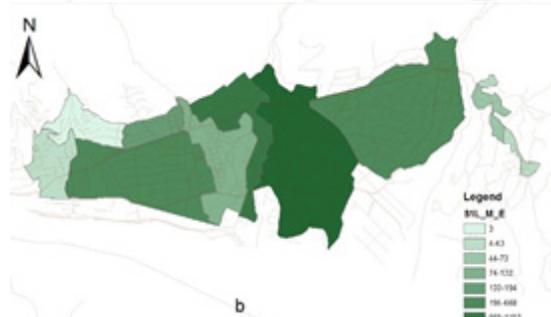
Fig 5: Area of Steel Moment Frame buildings with extensive damage in different areas of Lavasan city(m2), a: 4 to 8 story, b: 1 to 3 story

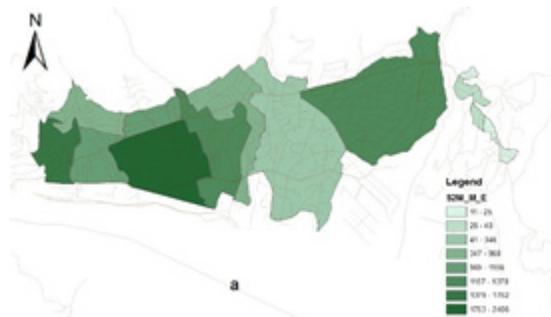
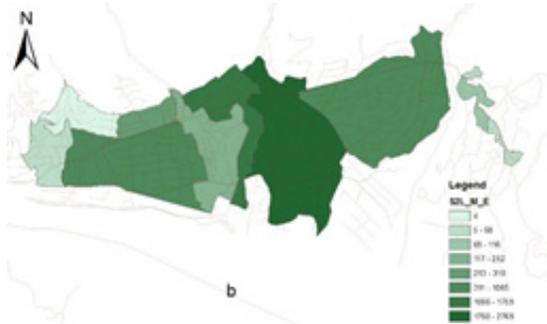
Fig 6: Area of Steel Braced Frame buildings with extensive damage in different areas of Lavasan city(m2), a: 4 to 8 story, b: 1 to 3 story

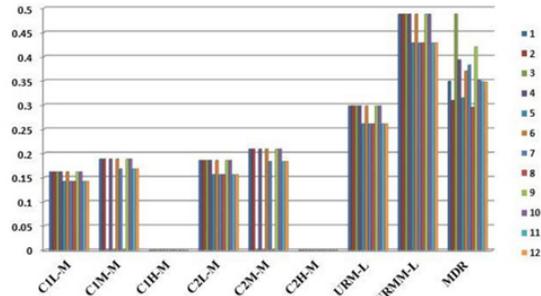
Fig 7: Mean damage ratio computed for concrete and masonry structures

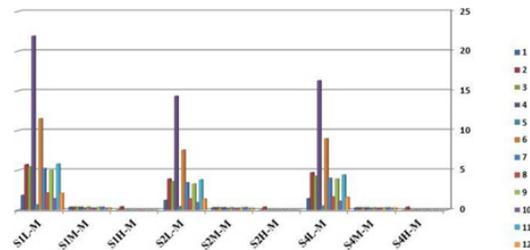
Fig 8: Mean damage ratio computed for steel structures

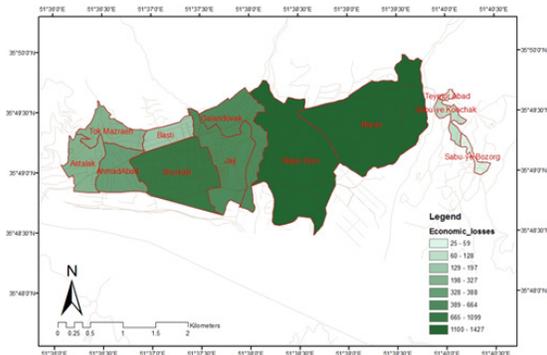
Fig 8: The amount of economic losses caused by earthquakes in different areas (10^9 Rials)

SELENA can also estimate the total amount of economic losses (in any input currency) due to structural damage in any geographical region. Economic loss for building renovation (and for reconstruction, in the case of complete damage) is computed based on the following equation (Molina, et al. 2012):
